**International Road Tunnel Fire Detection  
Research Project – Phase II**

**Task 7: Full-Scale Ventilated Fire Tests in a Laboratory  
Tunnel for Study of Tunnel Fire Detection Technologies**

**Z. G. Liu, G. Crampton, A. Kashef, G. Lougheed, E. Gibbs  
and S. Muradori**  
National Research Council of Canada

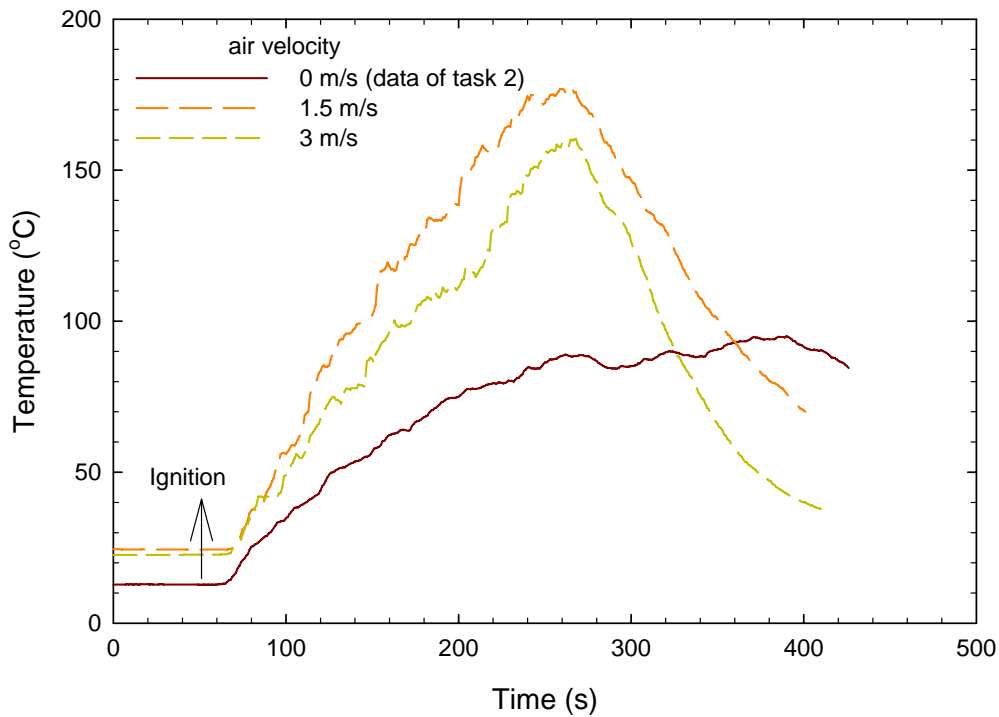
**Figure 7.21. Ceiling temperatures measured at Thermocouple #33 at center of the tunnel with a 2.0 m<sup>2</sup> gasoline pan fire with three airflow velocities**

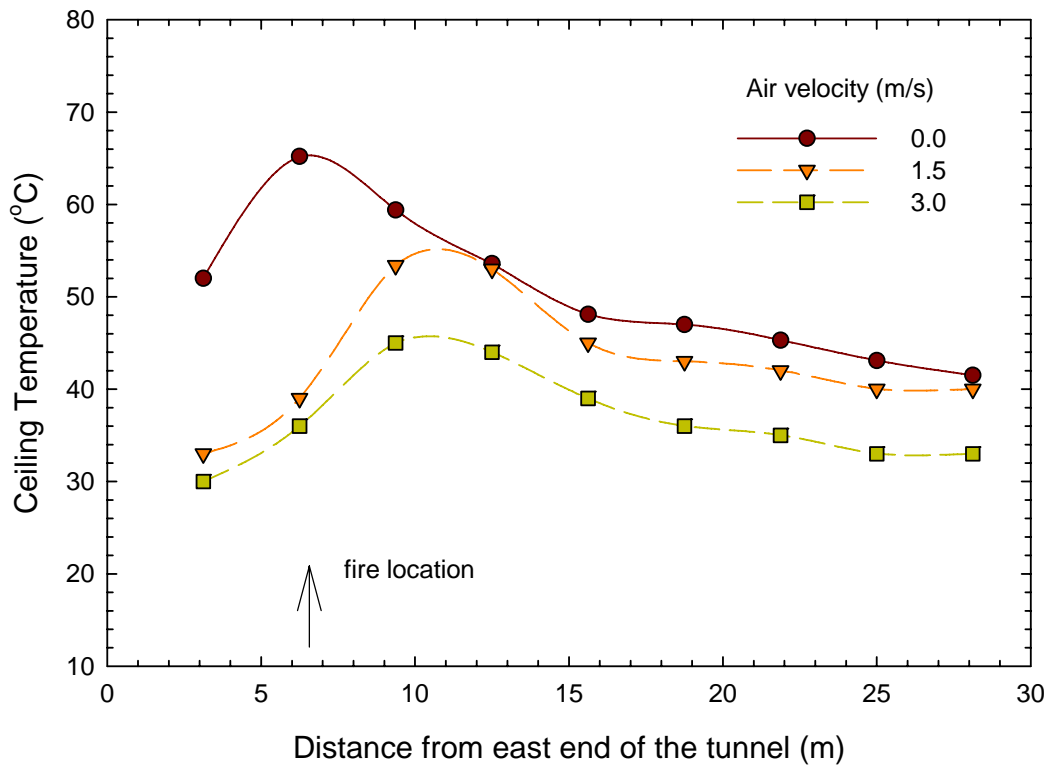
Figure 7.22. Maximum ceiling temperatures measured at the center of the tunnel with a  $0.36 \text{ m}^2$  gasoline pan fire with three airflow velocities

The hot spot at the ceiling was shifted downstream of the fire source under airflow conditions. The hot spot shifted from the fire location with an increase in airflow speed. The maximum distance that the hot spot was shifted at an airflow velocity of 3 m/s was approximately 6 m.

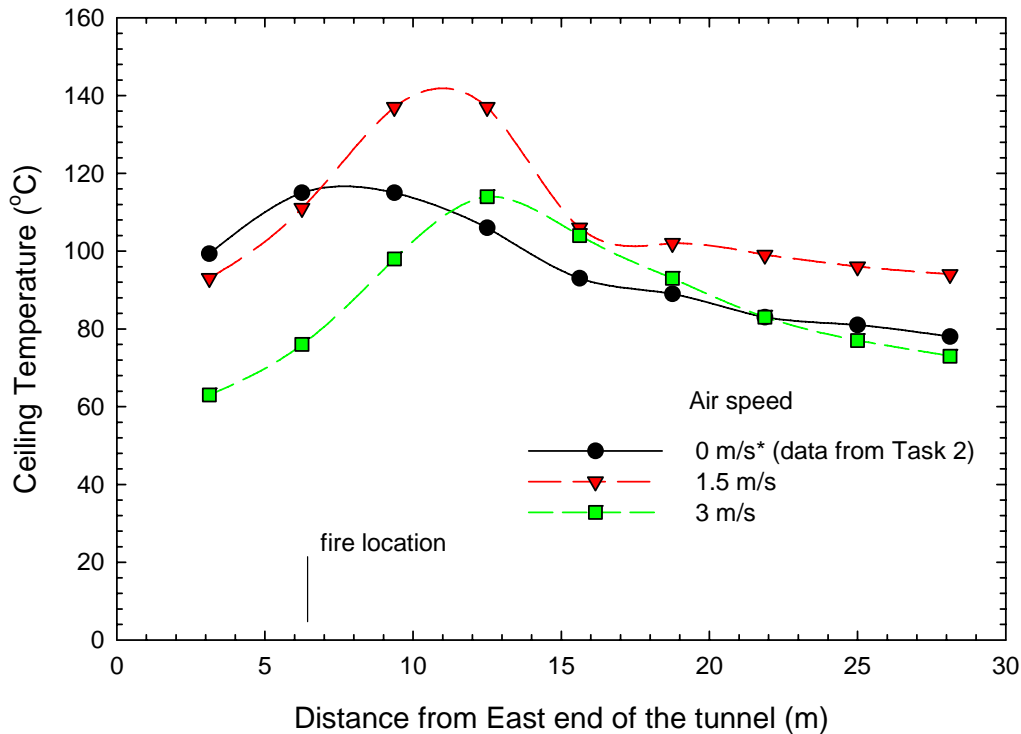
**Figure 7.23. Maximum ceiling temperatures measured at the center of the tunnel with a 1.0 m<sup>2</sup> gasoline pan fire with three airflow velocities**

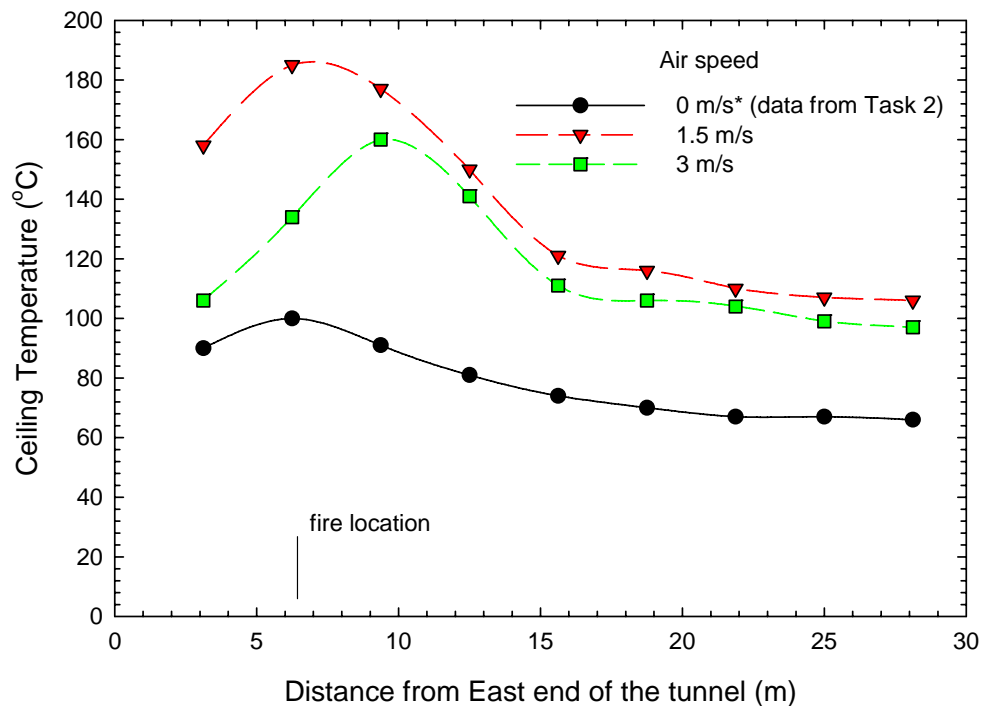
Figure 7.24. Maximum ceiling temperatures measured at the center of the tunnel with a 2.0 m<sup>2</sup> gasoline pan fire with three air velocities

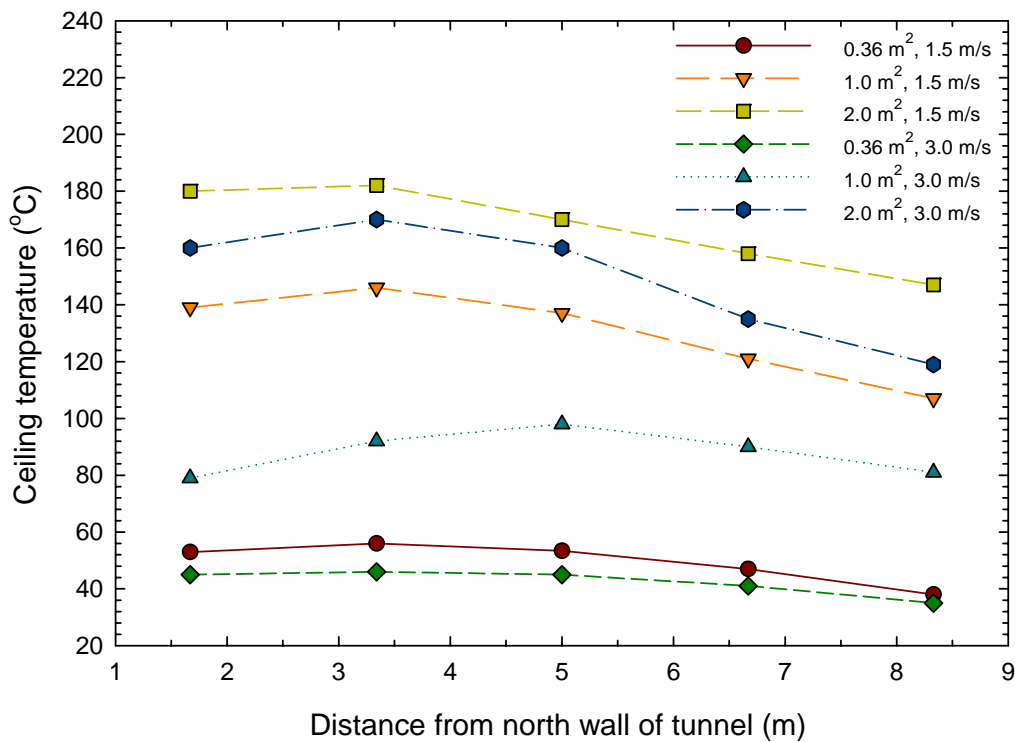
Figure 7.25. Maximum ceiling temperatures across the tunnel 3 m downstream of the fire with three pool fires and two airflow velocities

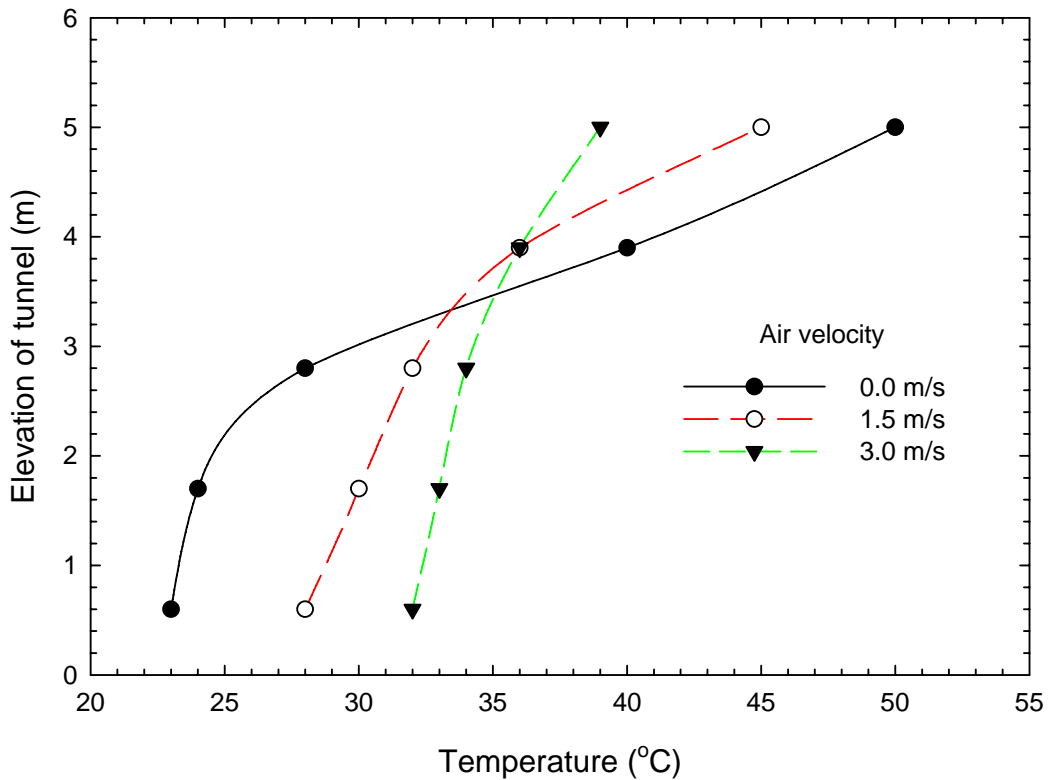
Figure 7.26. Maximum temperatures with elevation at the middle of the tunnel with a 0.36 m<sup>2</sup> gasoline pan fire with three air velocities

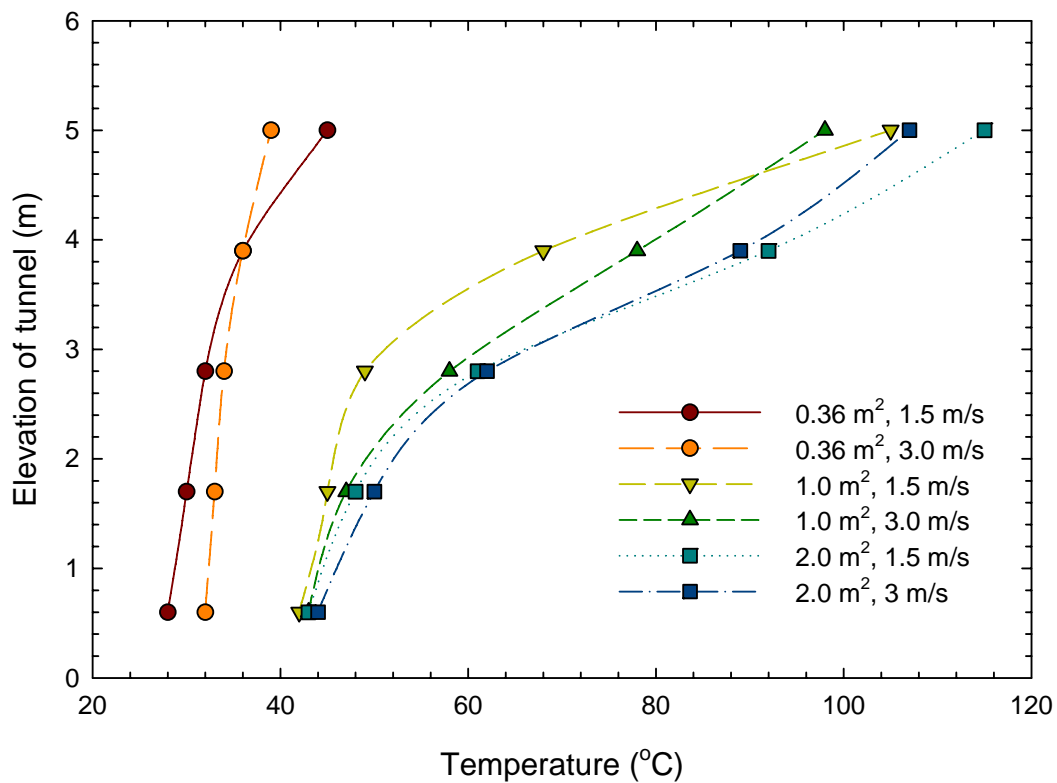
Figure 7.27. Maximum temperatures with elevation at the middle of the tunnel with three gasoline pan fires with two airflow velocities

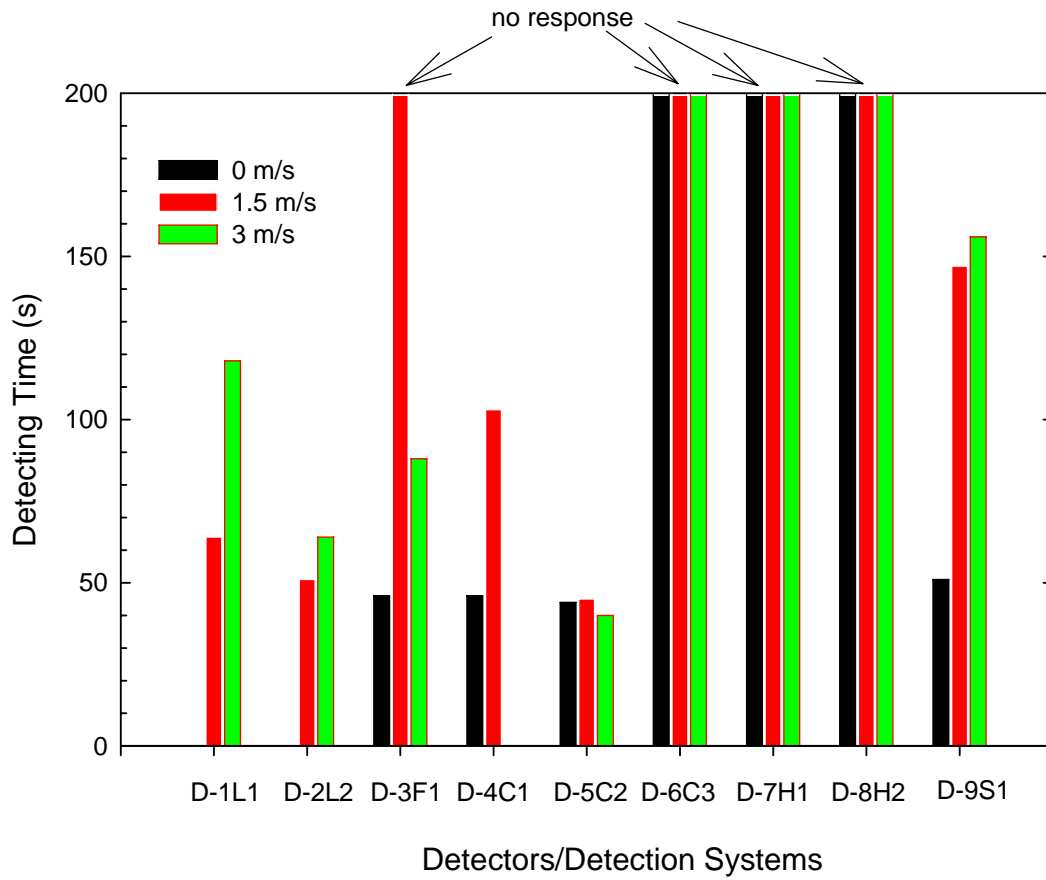
**Figure 7.28. Response times of fire detectors/detection systems to a 0.36 m<sup>2</sup> fire located underneath the vehicle at three airflow velocities**

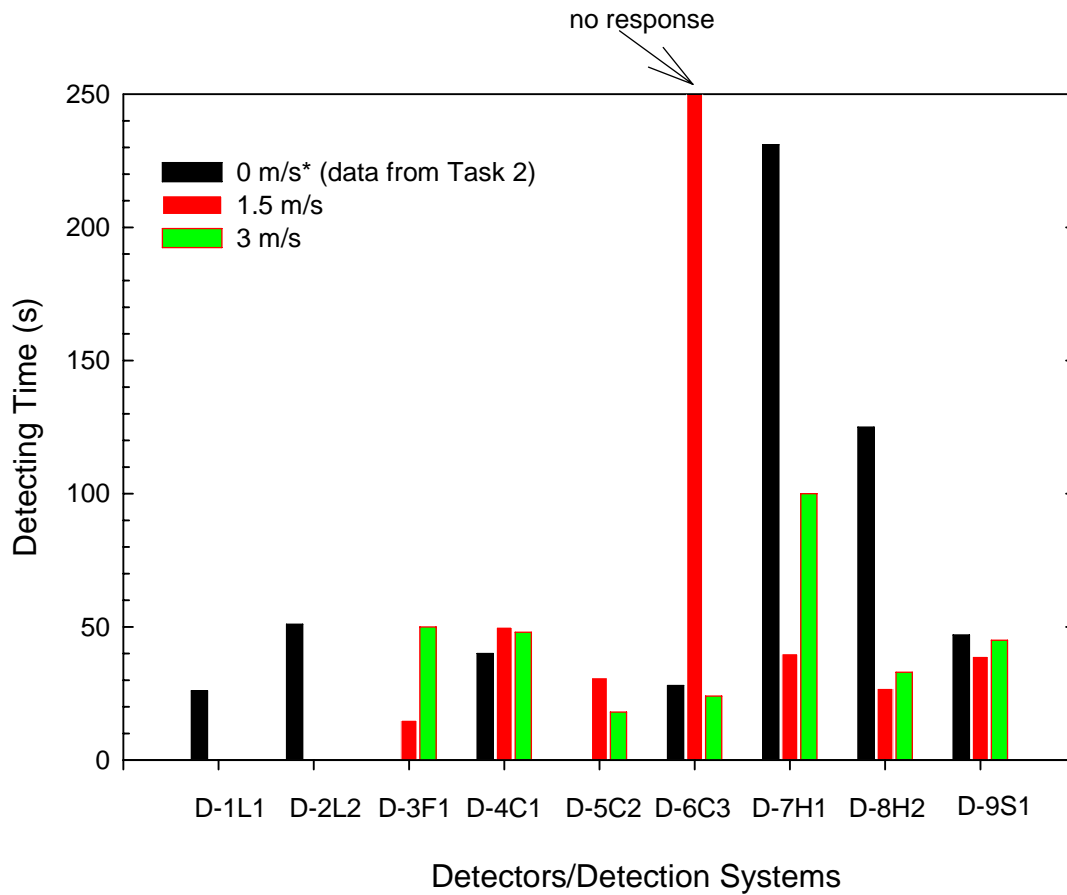
**Figure 7.29. Response times of fire detectors/detection systems to a 1.0 m<sup>2</sup> fire located underneath the vehicle at three airflow velocities**

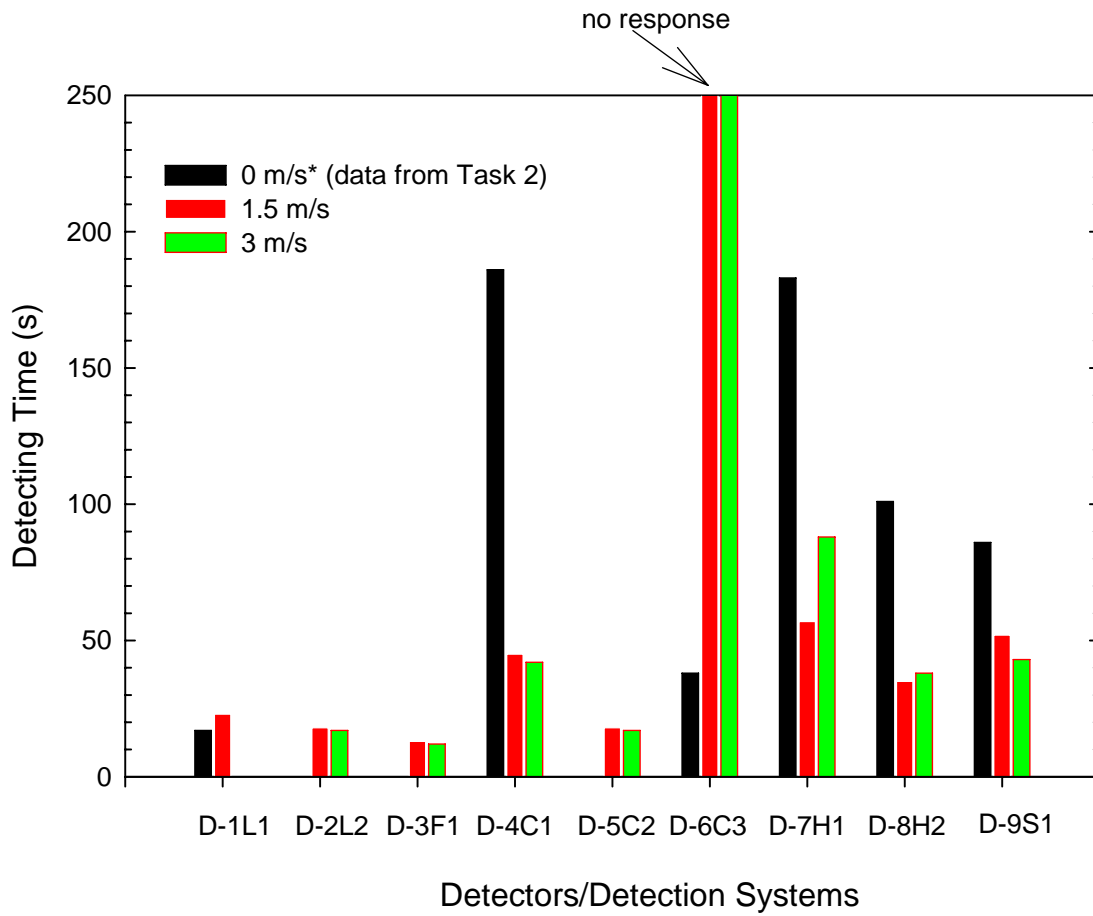
**Figure 7.30. Response times of fire detectors/detection systems to a 2.0 m<sup>2</sup> fire located underneath the vehicle at three airflow velocities**

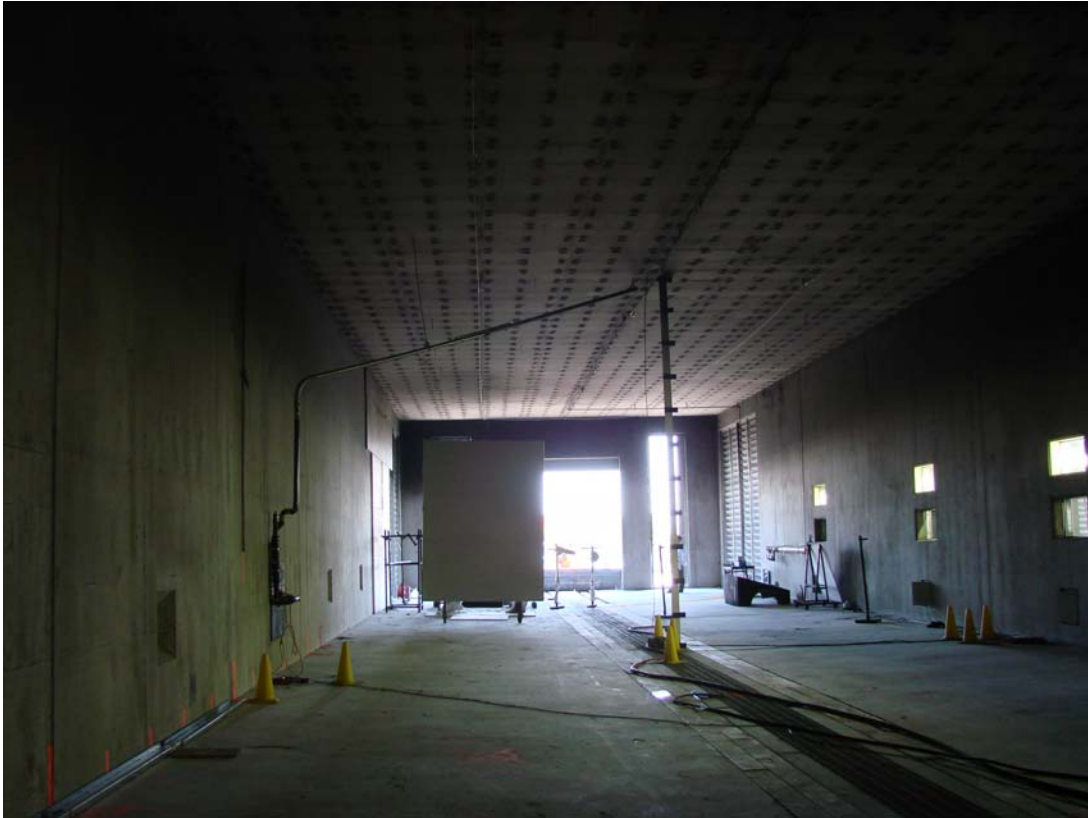
**Figure 7.31. Photograph of the setup of a pool fire located behind a large simulated vehicle in the test tunnel**

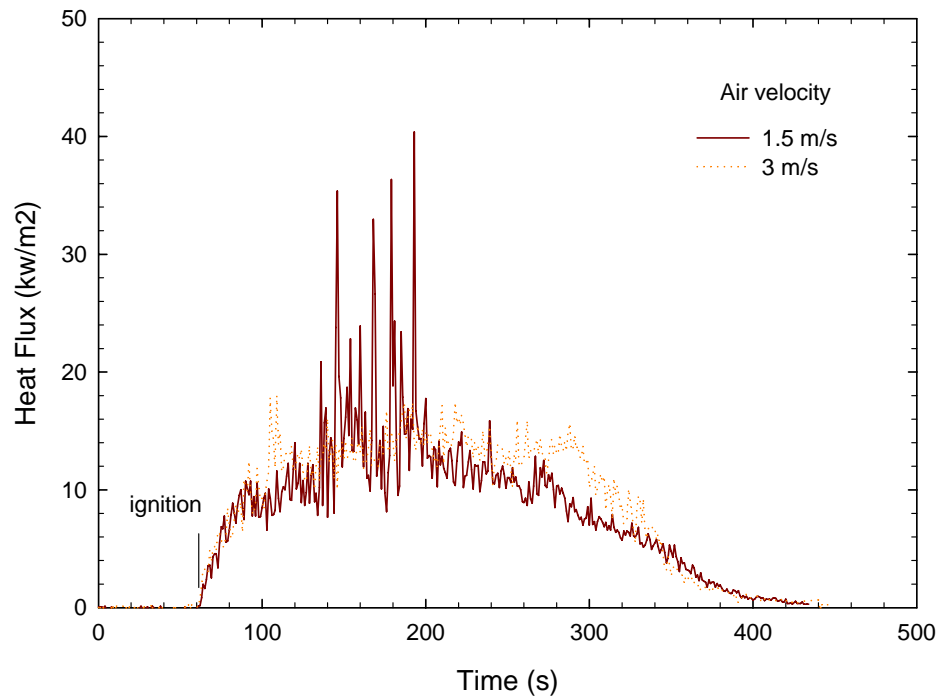
**Figure 7.32. Heat flux measured 1 m from a 1.0 m<sup>2</sup> fire located behind a vehicle at two airflow velocities**

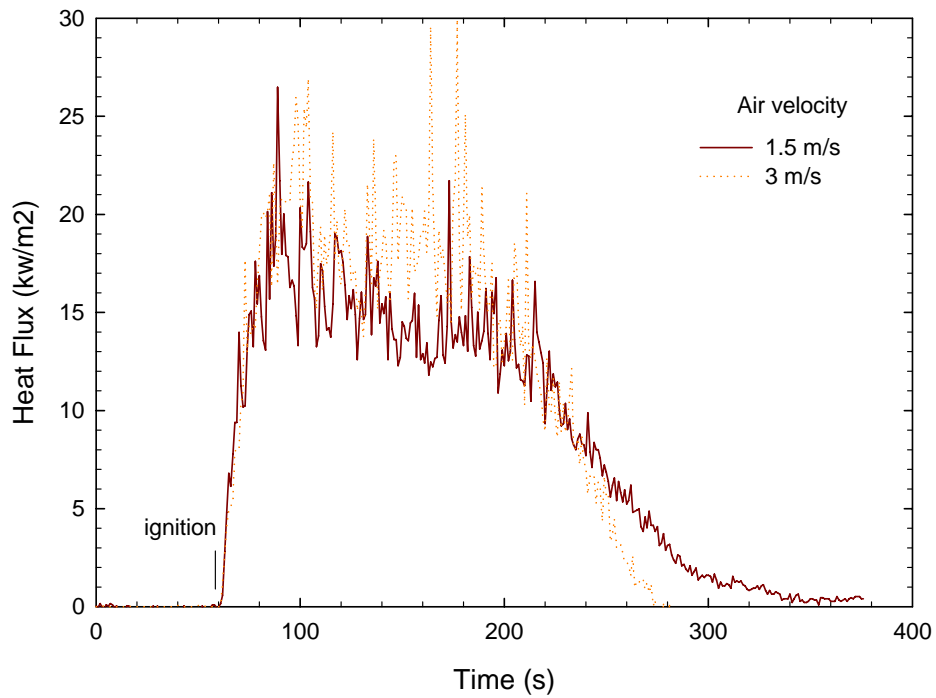
**Figure 7.33. Heat flux measured 1 m from a 2.0 m<sup>2</sup> fire located behind a vehicle at two airflow velocities**

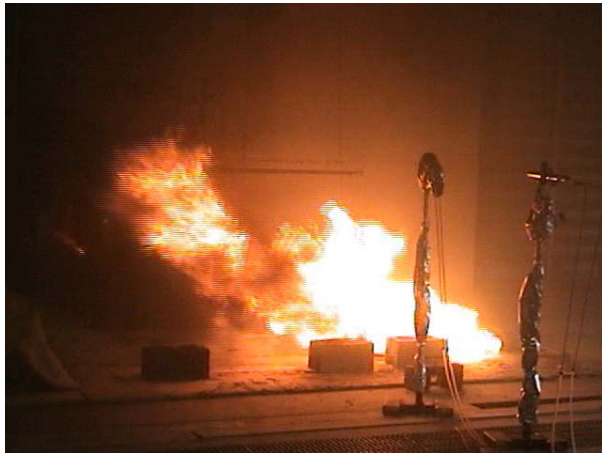
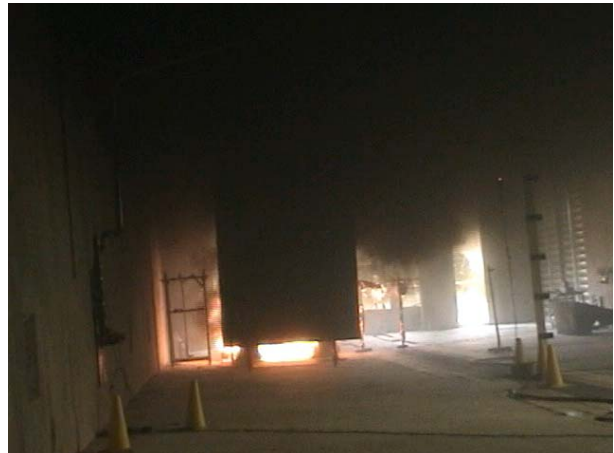
Figure 7.34. A  $1.0 \text{ m}^2$  gasoline pool fire located behind the vehicle at  $1.5 \text{ m/s}$  airflow velocity 1 minute after ignition

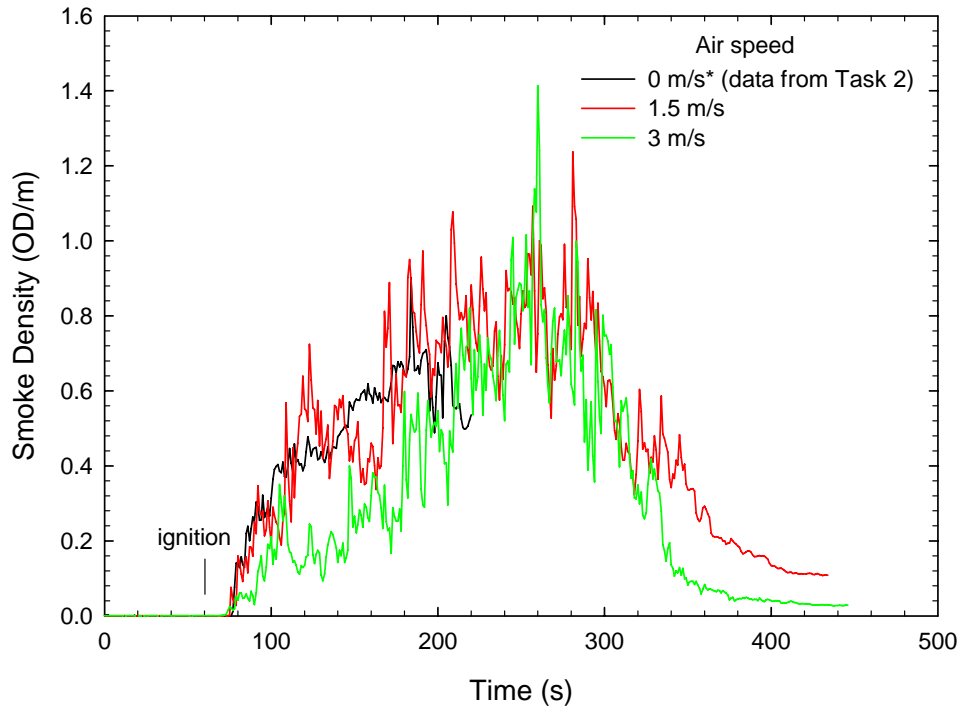
**Figure 7.38. Smoke optical density near the ceiling measured at the middle of the tunnel for a 1.0 m<sup>2</sup> fire located behind a vehicle at three airflow speeds**

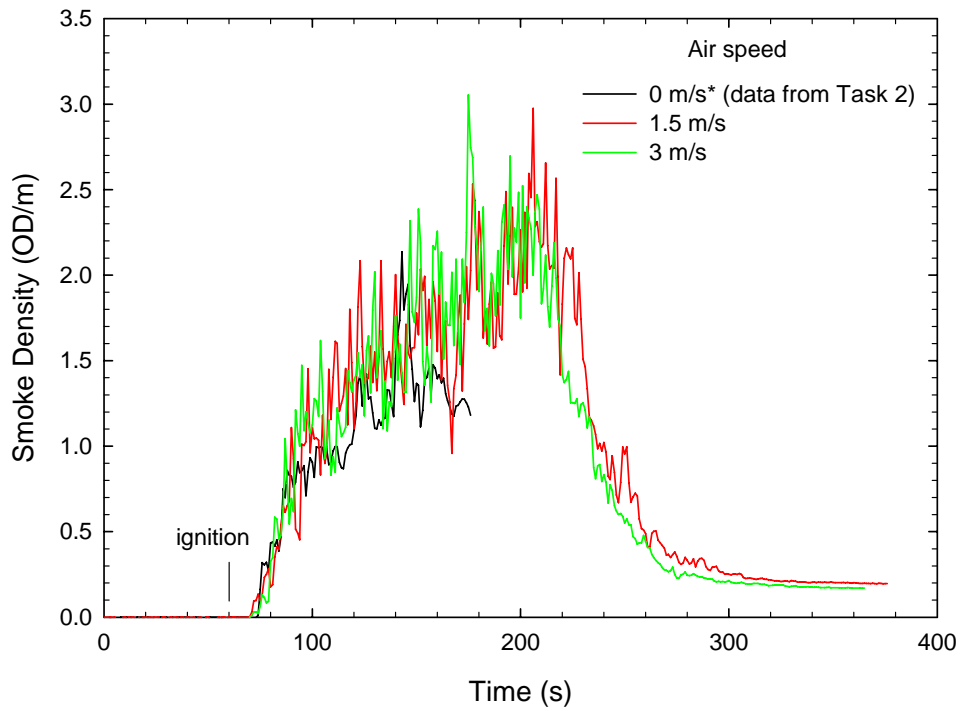
**Figure 7.39. Smoke optical density near the ceiling measured at the middle of the tunnel for a 2.0 m<sup>2</sup> fire located behind a vehicle at three airflow speeds**

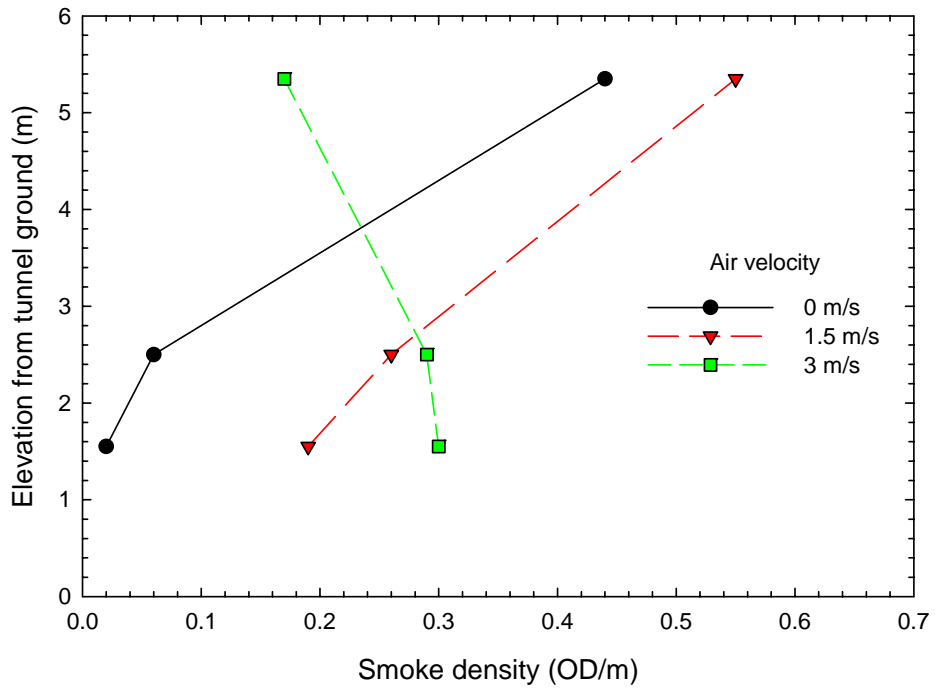
Figure 7.40. Variation of smoke optical density with elevation at three airflow speeds for a 1.0 m<sup>2</sup> fire located behind a vehicle 70 s after ignition

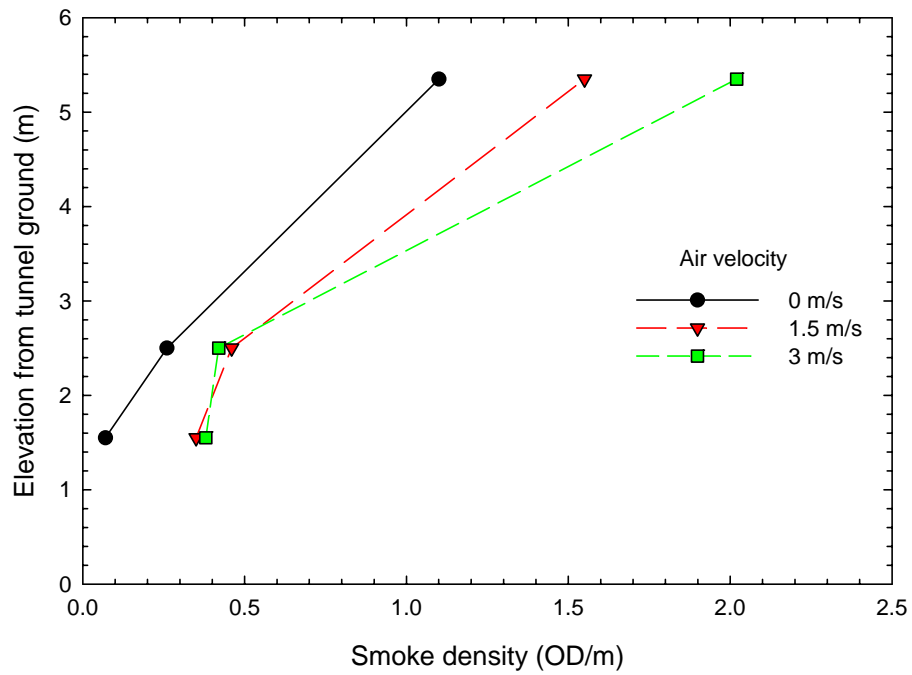
Figure 7.41. Variation of smoke optical density with elevation at three airflow speeds for a 2.0 m<sup>2</sup> fire located behind a vehicle 70 s after ignition

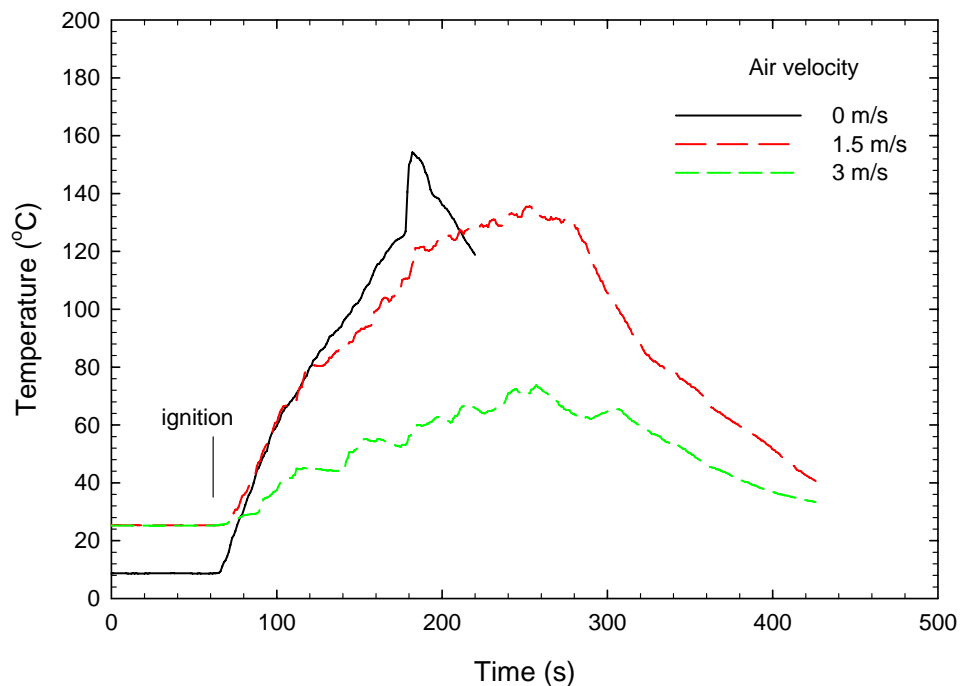
Figure 7.42. Ceiling temperatures measured at Thermocouple #33 at center of the tunnel with a 1.0 m<sup>2</sup> gasoline pan fire for three airflow velocities

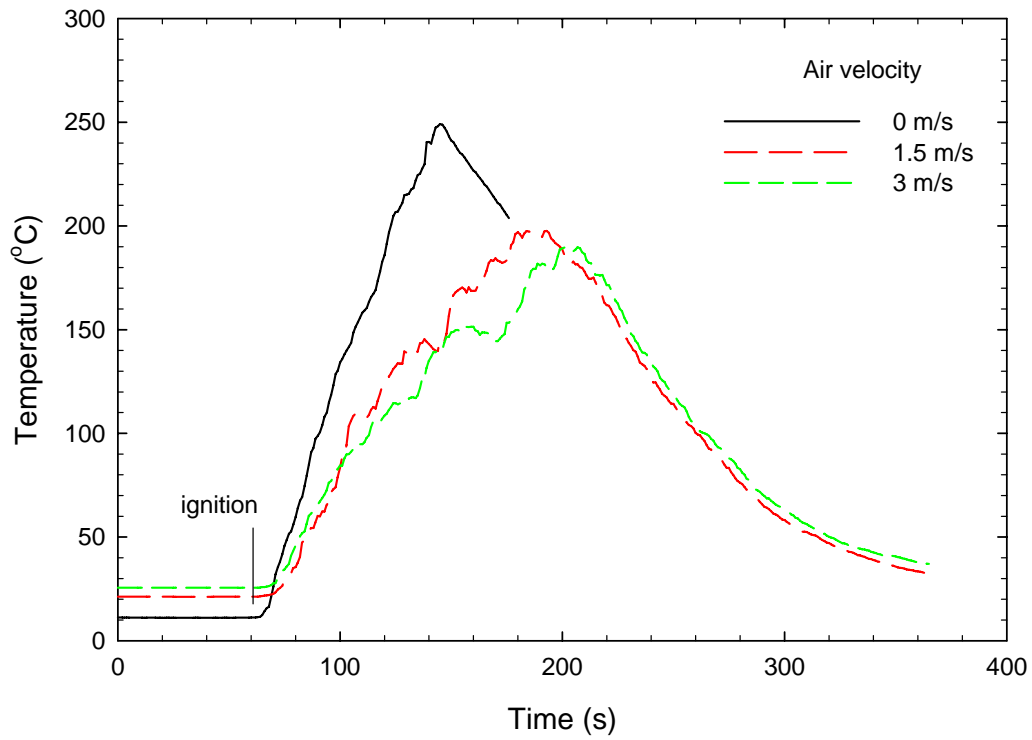
**Figure 7.43. Ceiling temperatures measured at Thermocouple #33 at center of the tunnel with a 2.0 m<sup>2</sup> gasoline pan fire for three airflow velocities**

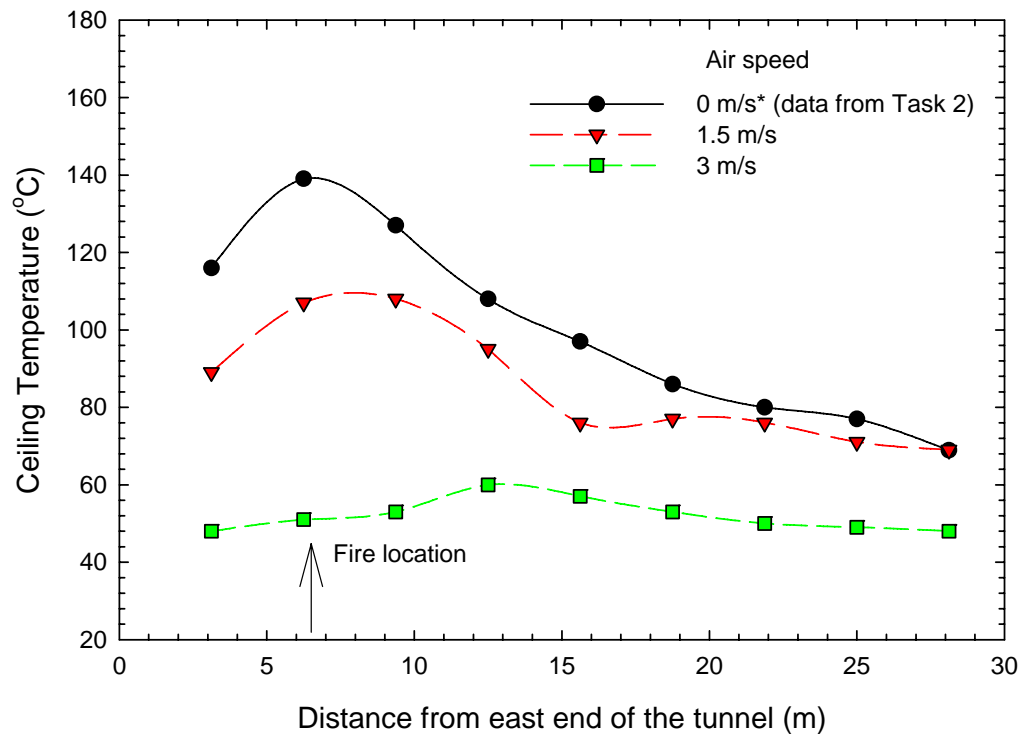
**Figure 7.44. Variation of ceiling temperatures along the centerline of the tunnel with a 1.0 m<sup>2</sup> gasoline pan fire for three airflow velocities 115 s after ignition**

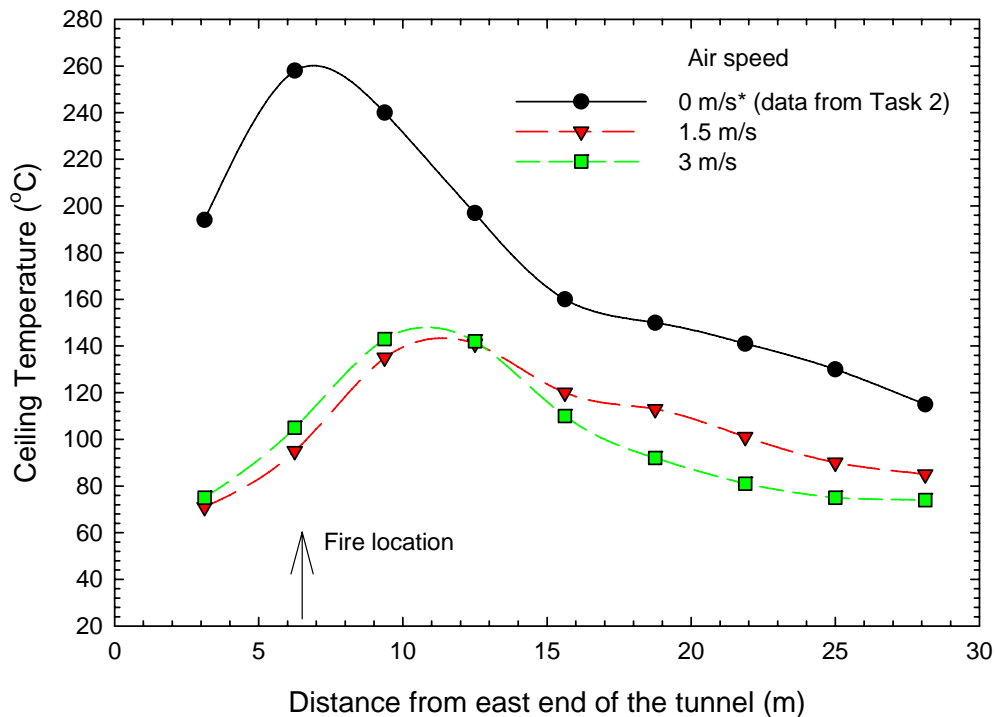
Figure 7.45. Variation in ceiling temperature along the centerline of the tunnel with a 2.0 m<sup>2</sup> gasoline pan fire for three airflow velocities 80 s after ignition

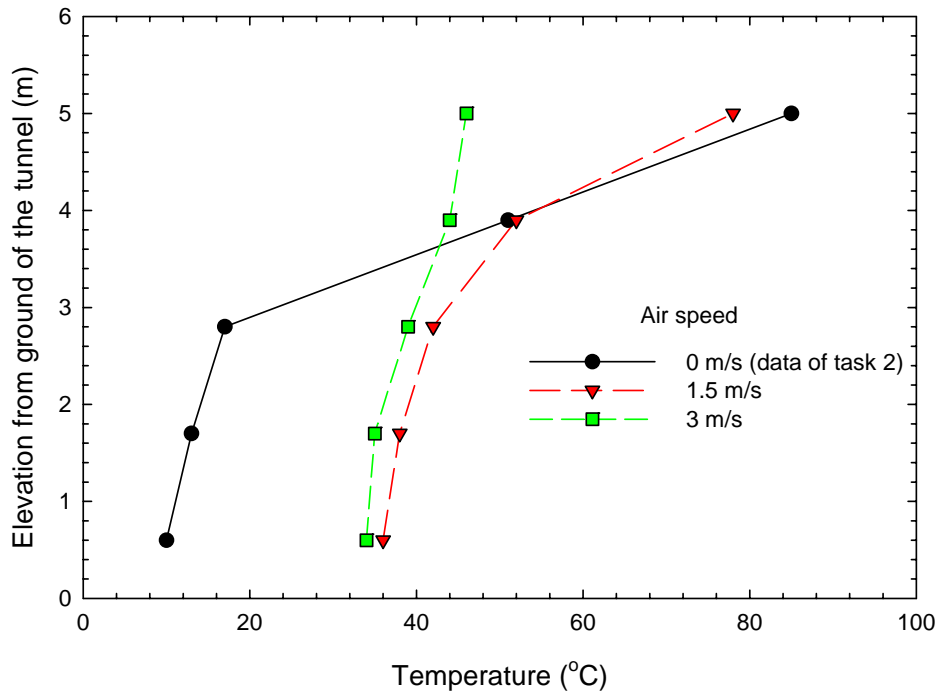
Figure 7.46. Variation of temperatures with elevation for a 1.0 m<sup>2</sup> gasoline pan fire 115 s after ignition

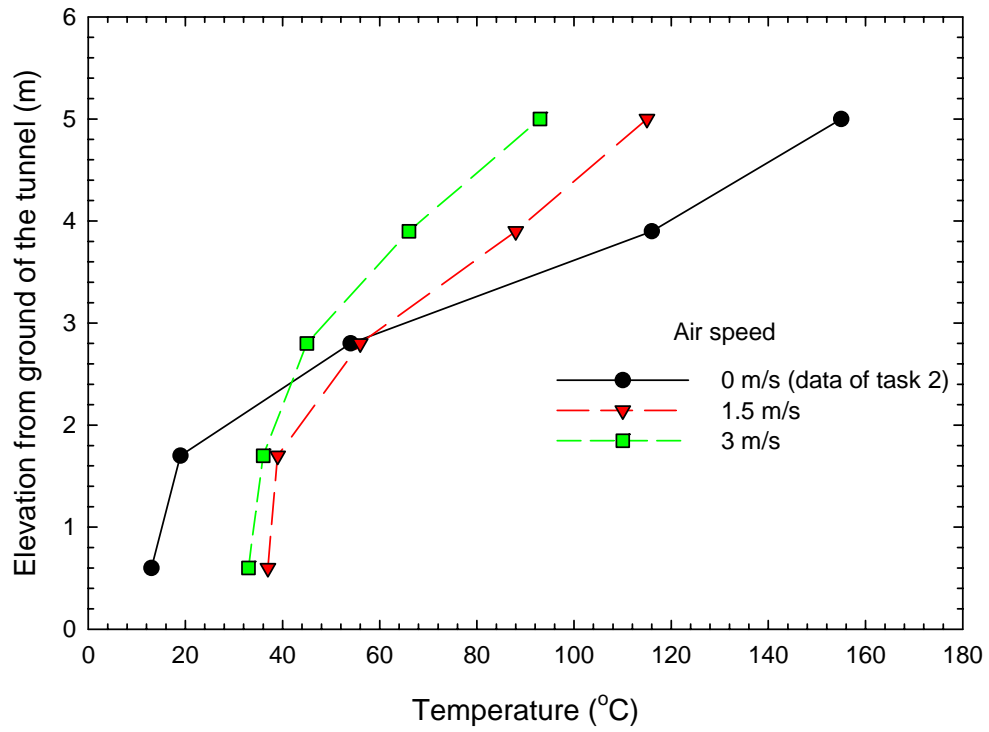
Figure 7.47. Variation of temperatures with elevation for a 2.0 m<sup>2</sup> gasoline pan fire 80 s after ignition

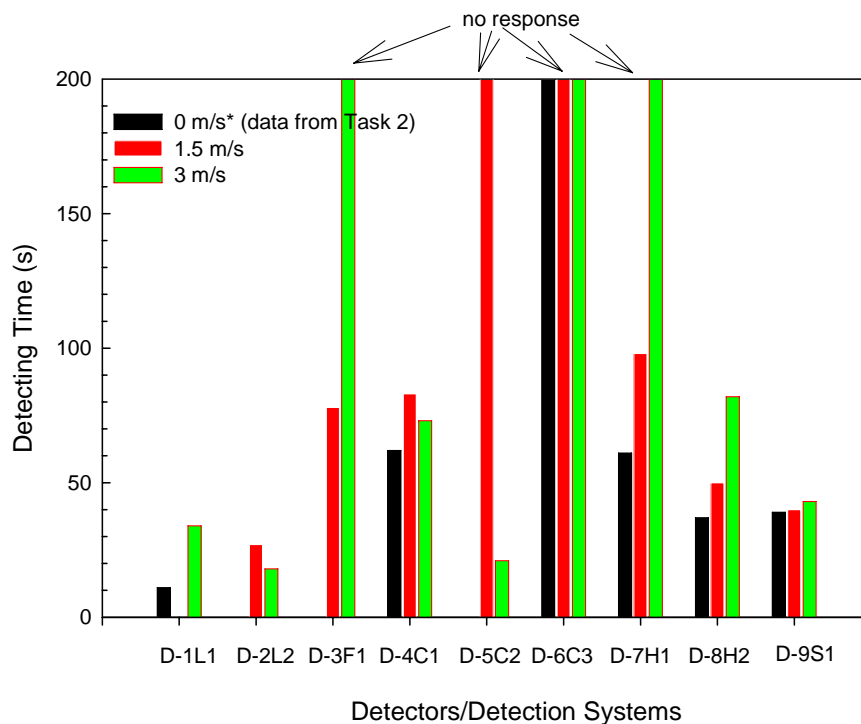
**Figure 7.48. Response times of fire detectors/detection systems to a 1.0 m<sup>2</sup> fire located behind a vehicle**

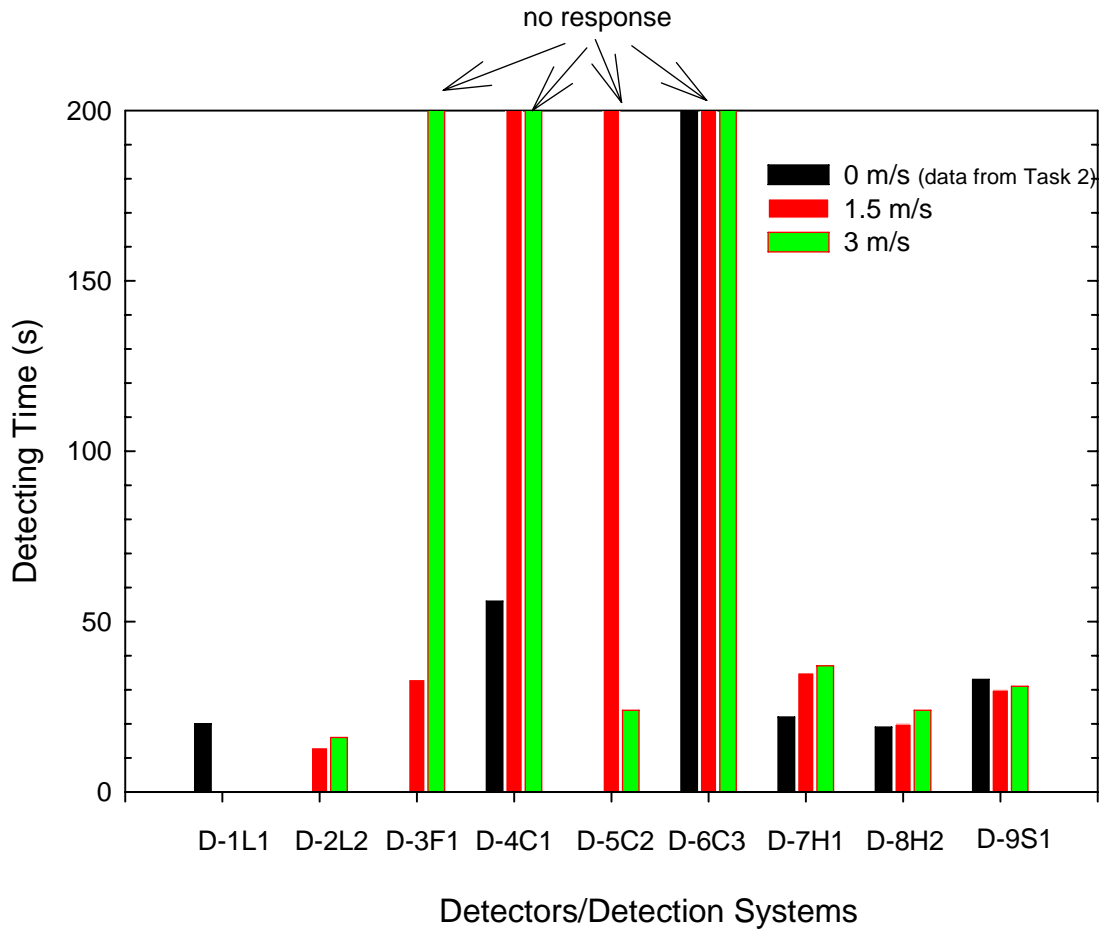
**Figure 7.49. Response times of fire detectors/detection systems to a 2.0 m<sup>2</sup> fire located behind a vehicle**

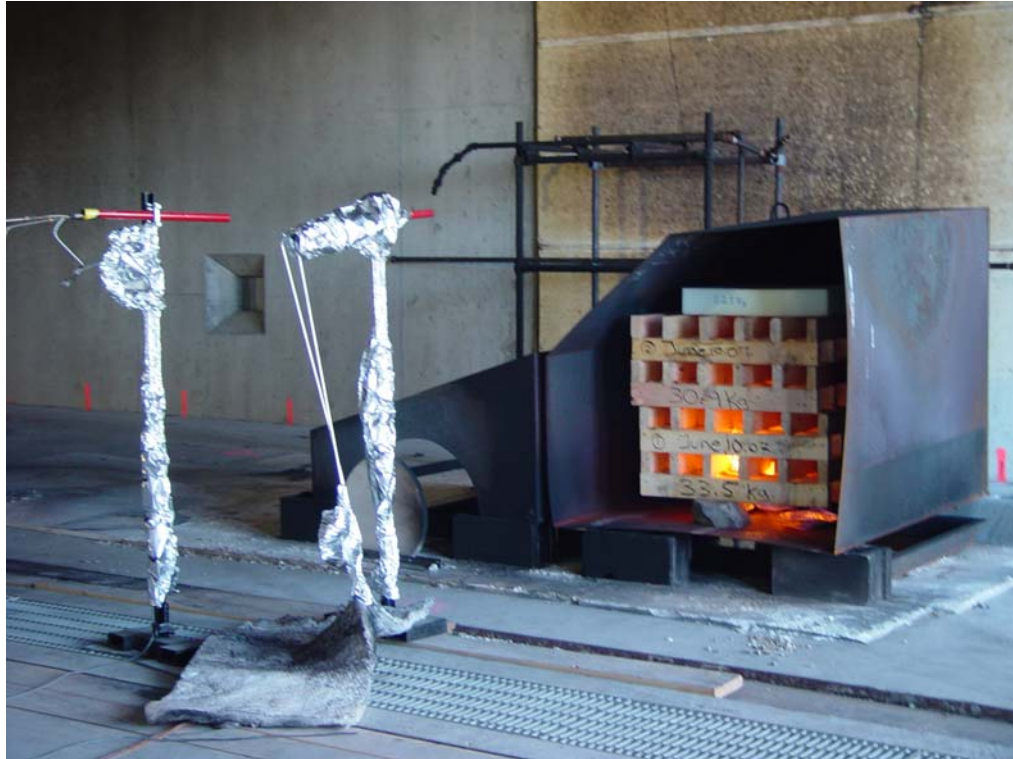
**Figure 7.50.** Photograph of the setup for a simulated passenger compartment vehicle fire

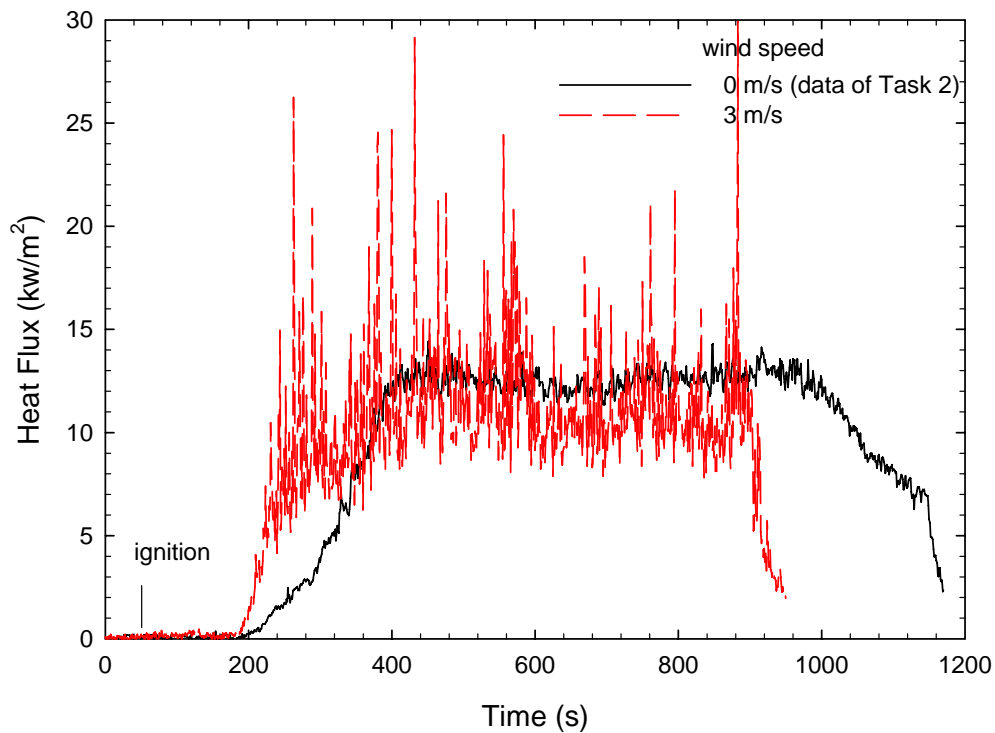
Figure 7.51. Variations of heat flux produced by a simulated passenger compartment fire

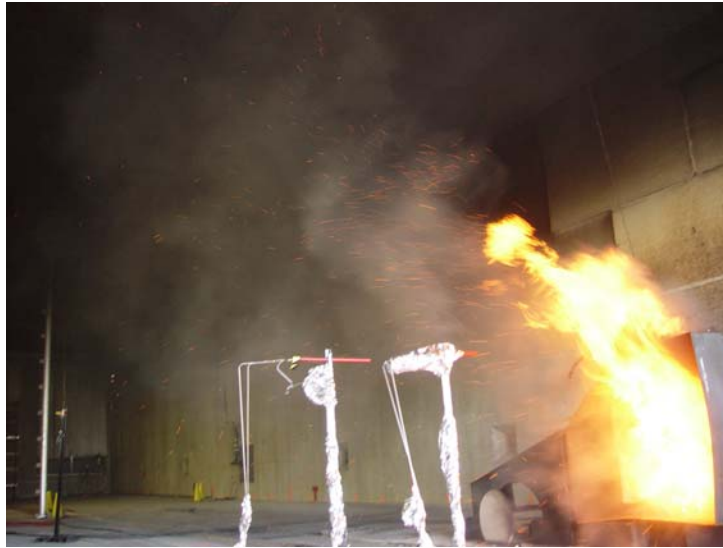
**Figure 7.52.** The side view of the simulated passenger compartment fire with wood cribs and foam with an airflow speed of 3 m/s

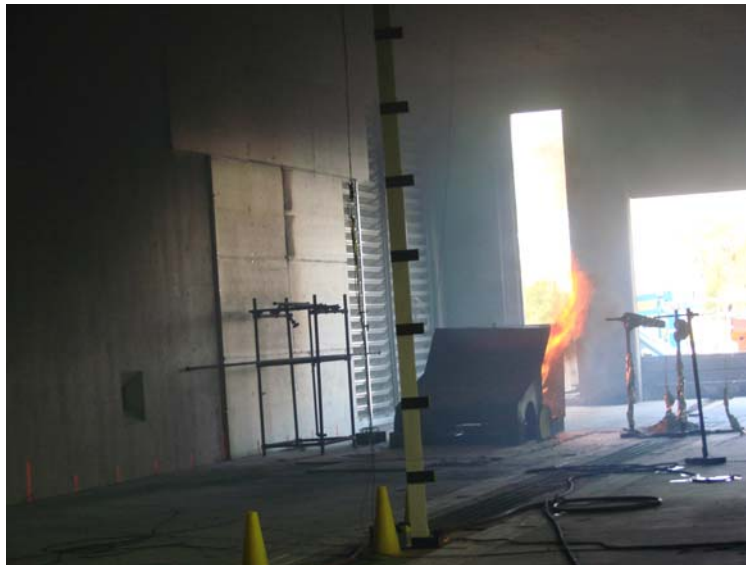
**Figure 7.53.** The front view of the simulated passenger compartment fire with wood cribs and foam with an airflow speed of 3 m/s
